CAUSAL FACTOR: Vehicle Speed - Attempted to Initiate a 90 Degree Turn
ROADSIDE DEPARTURE: Right

PSU No. 72

Case Number - Stratum 047K

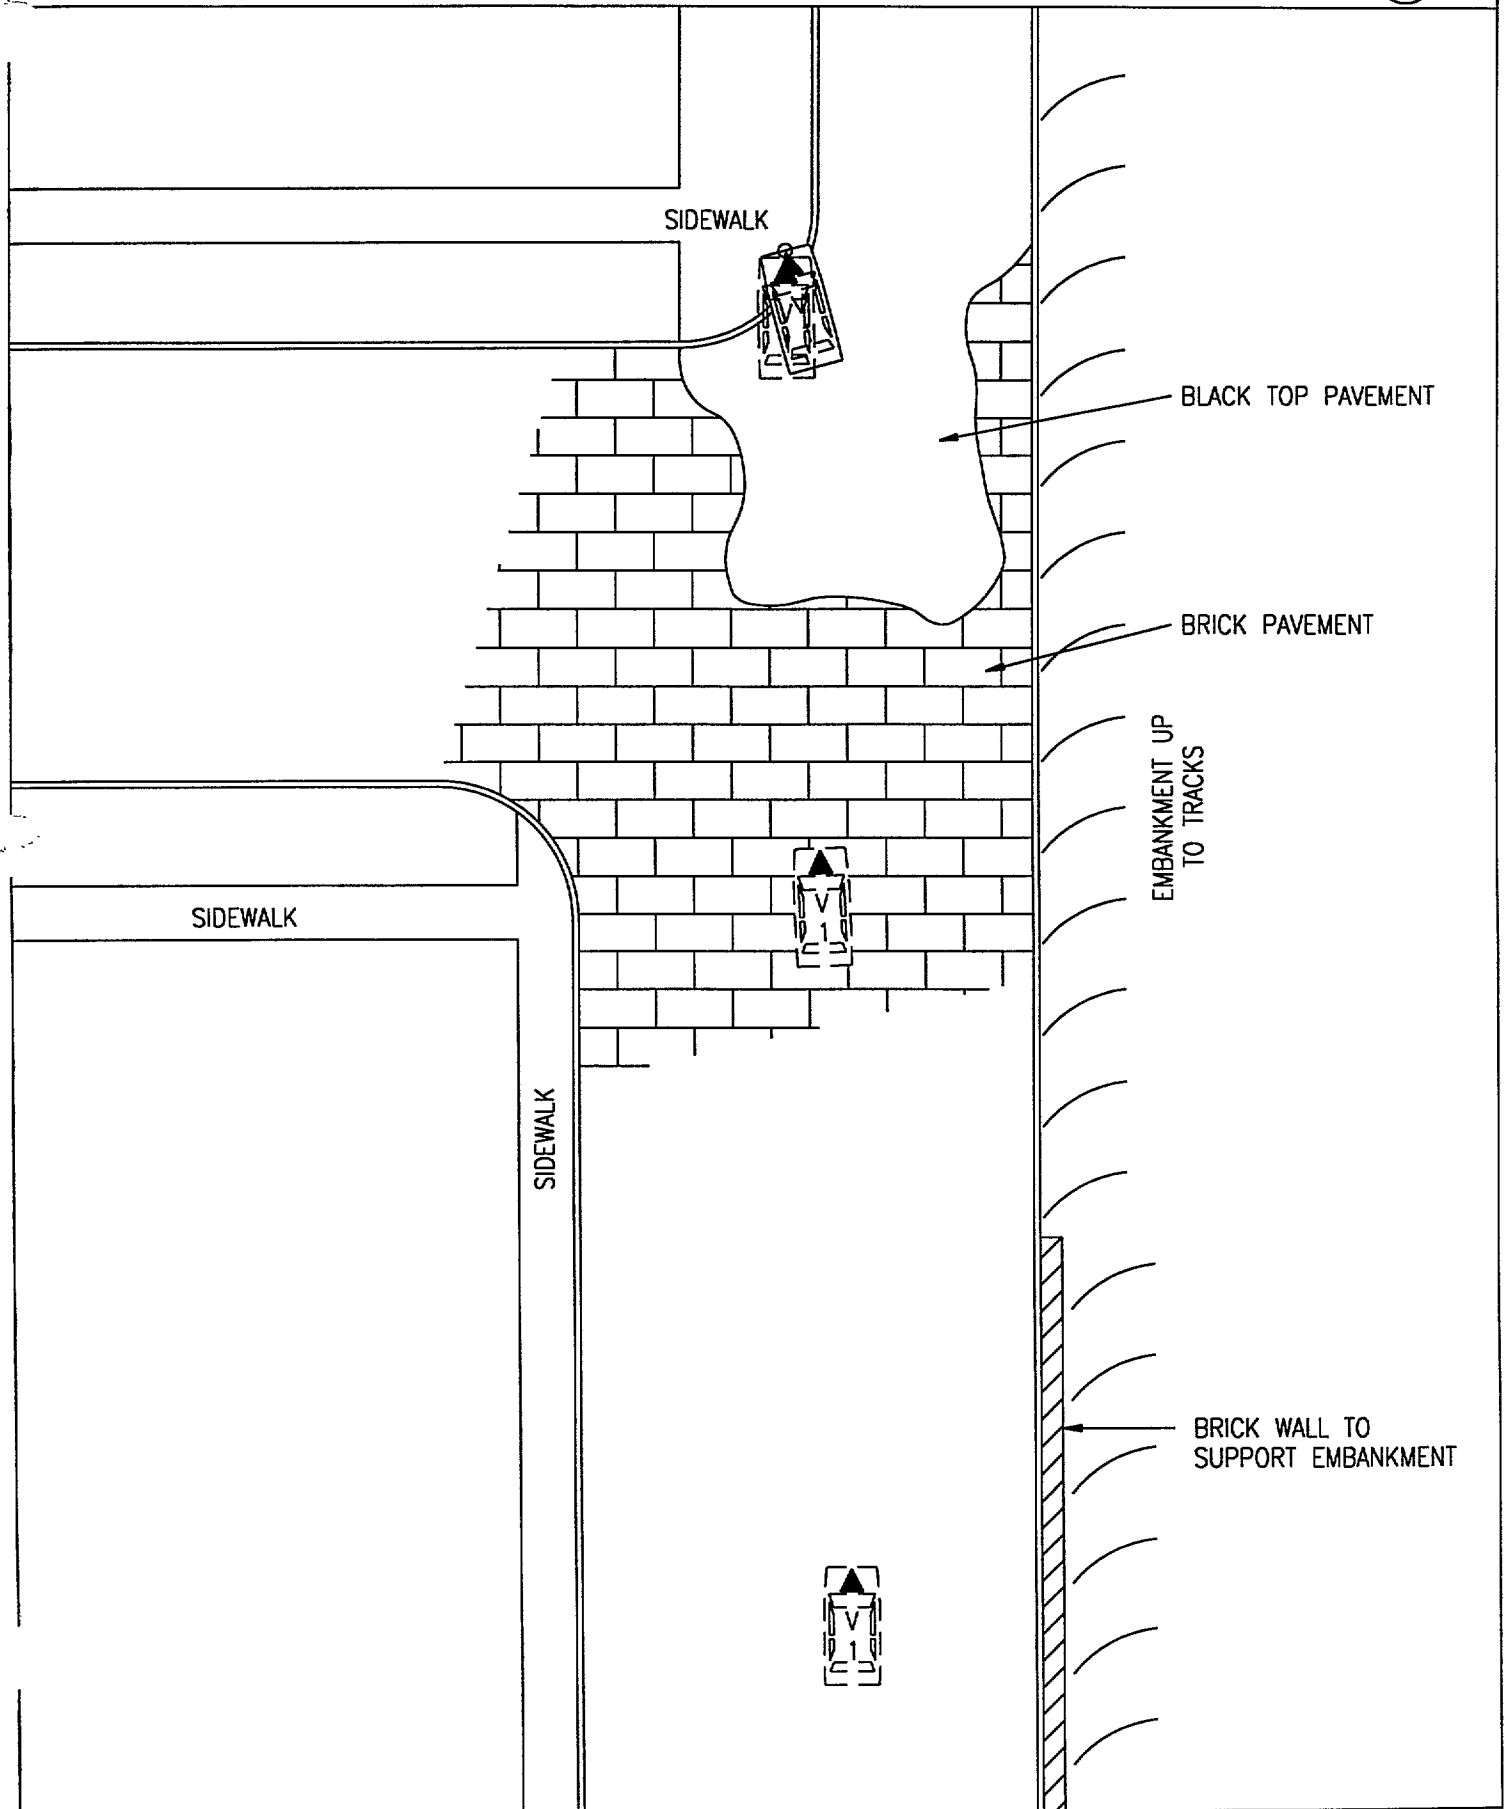
ACCIDENT COLLISION DIAGRAM

The subject vehicle was traveling through snowy weather in a westerly direction on a wet, two-lane urban cobblestone, street. As the vehicle approached a T-intersection with a north/south roadway, the driver attempted to decelerate to initiate a left turn onto the intersecting roadway. The vehicle skidded straight forward, and struck a utility pole located at the southwest corner of the intersection. The vehicle came to rest at the point of impact, in contact with the pole, facing in a west southwesterly direction. The roadway was dark with no artificial lighting and no surface markings. The driver was traveling too fast for the wet road surface.
